# Incident Report and Restoration Overview: Boat Grounding, Chalok Ban Kao Reef January 27th, 2015

## Incident Report and Restoration Overview Boat Grounding: Chalok Ban Kao Reef January 27<sup>th</sup>, 2015

Written by Chad Scott

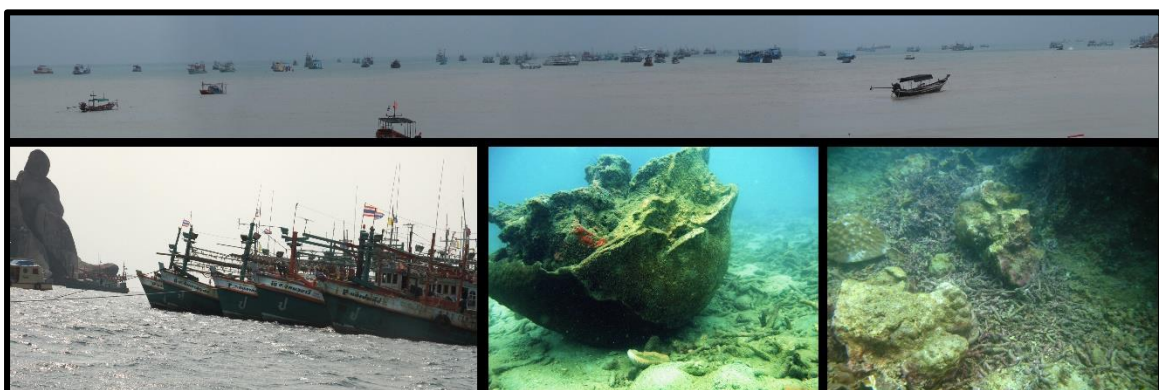
Chalok Ban Kao during a storm, showing the number of boats which frequently drop anchors in the bay, as well as some of the historically recorded damage in the area.

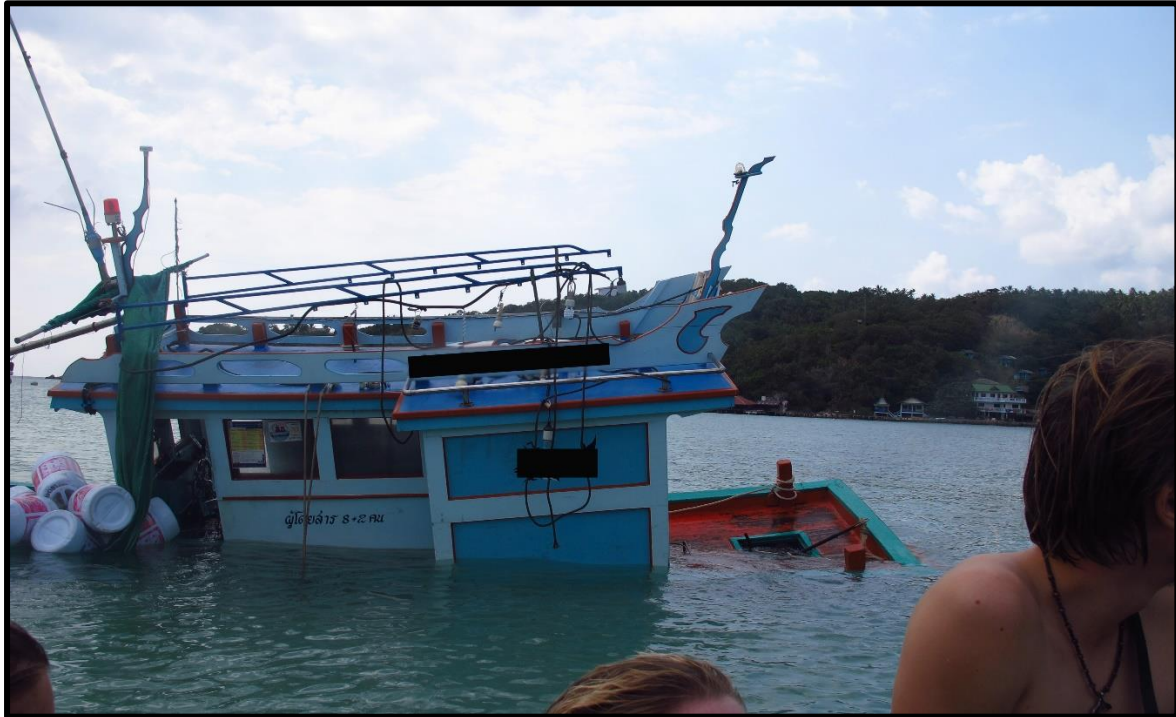
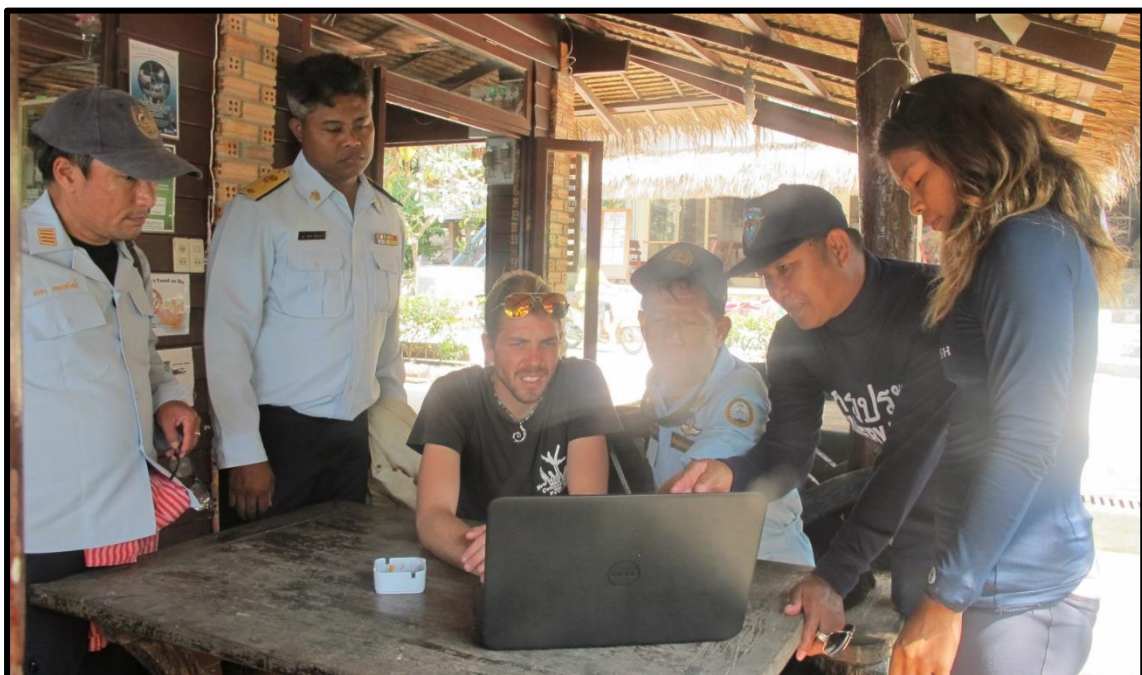
On January 27th of 2015, a fishing boat sank, and was subsequently dragged through the shallow reef of the bay in an attempt to lift it out of the water. This caused significant damage to the shallow reef area, crushing and killing entire stands of branching *Acropora* corals. The event was witnessed by our team, but due to storms we were not able to assess the damage until February 2<sup>nd</sup>, 2015. The NHRCP team performed several surveys of the damaged areas, and reported the incident to the Department of Marine and Coastal Resources, who did their own assessment of the area. It was determined that the area needed to be restored, and the NHRCP team began such work the same

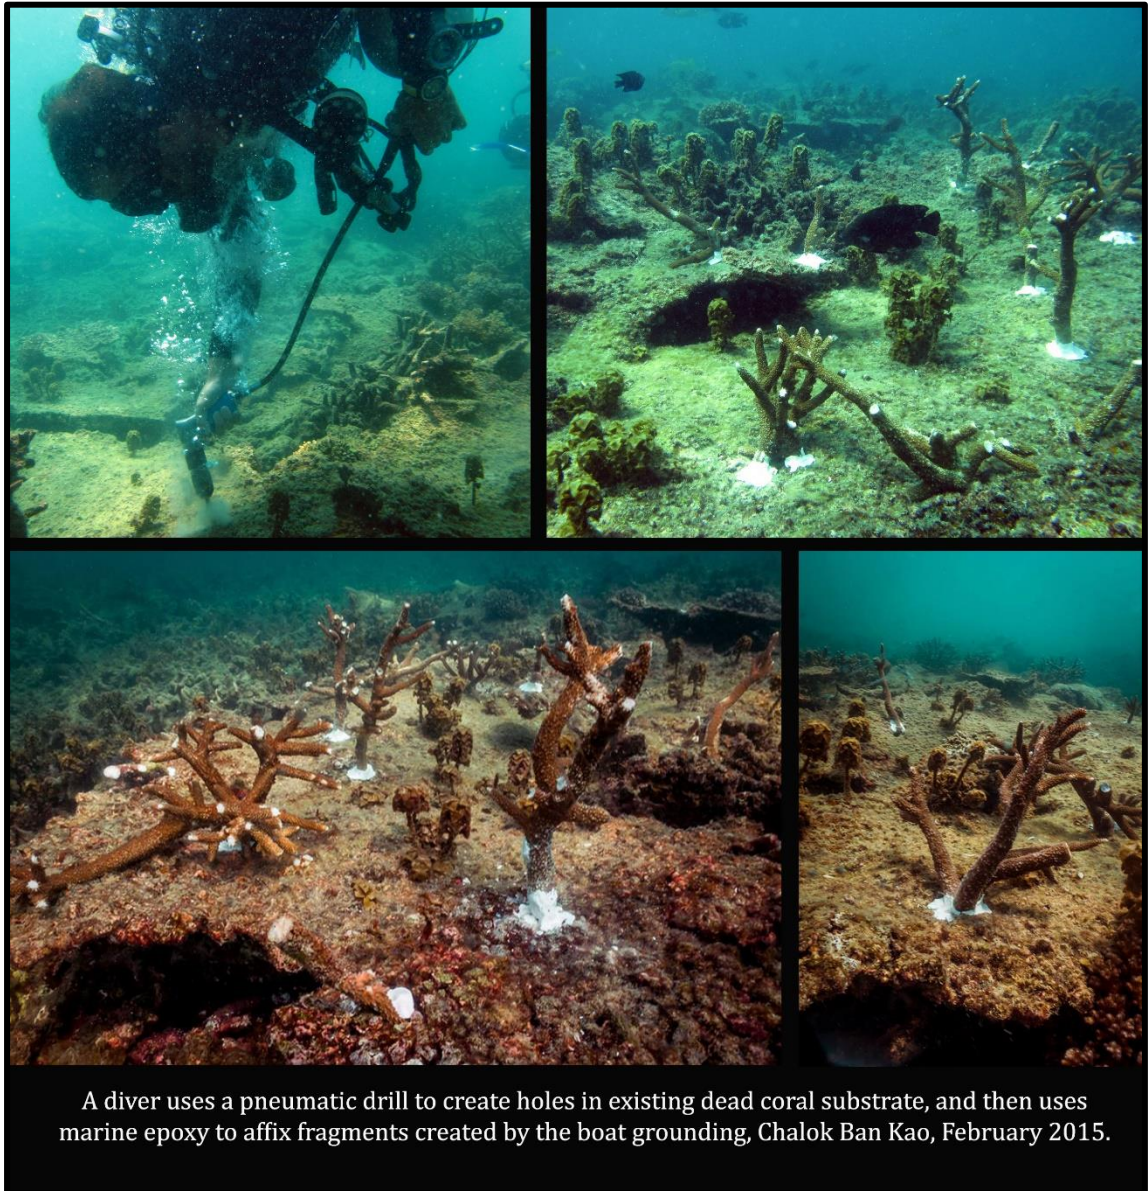
The boat grounding caused most of the branching, corymbose, and plate corals in the area to be broken into fragments, which if left unmanaged would most likely die through abrasion, smothering, or predation. Divers worked quickly to secure the fragments in place using coral gardening techniques. Large fragments were righted, and secured in the coral rubble using wedges (i.e. pieces of dead coral) or other techniques that did not require any additional materials. In other cases, a pneumatic drill was used to create holes in existing substrate (dead massive and tabulate corals from previous bleaching events) and were secured using underwater epoxy, as shown in the photos below.

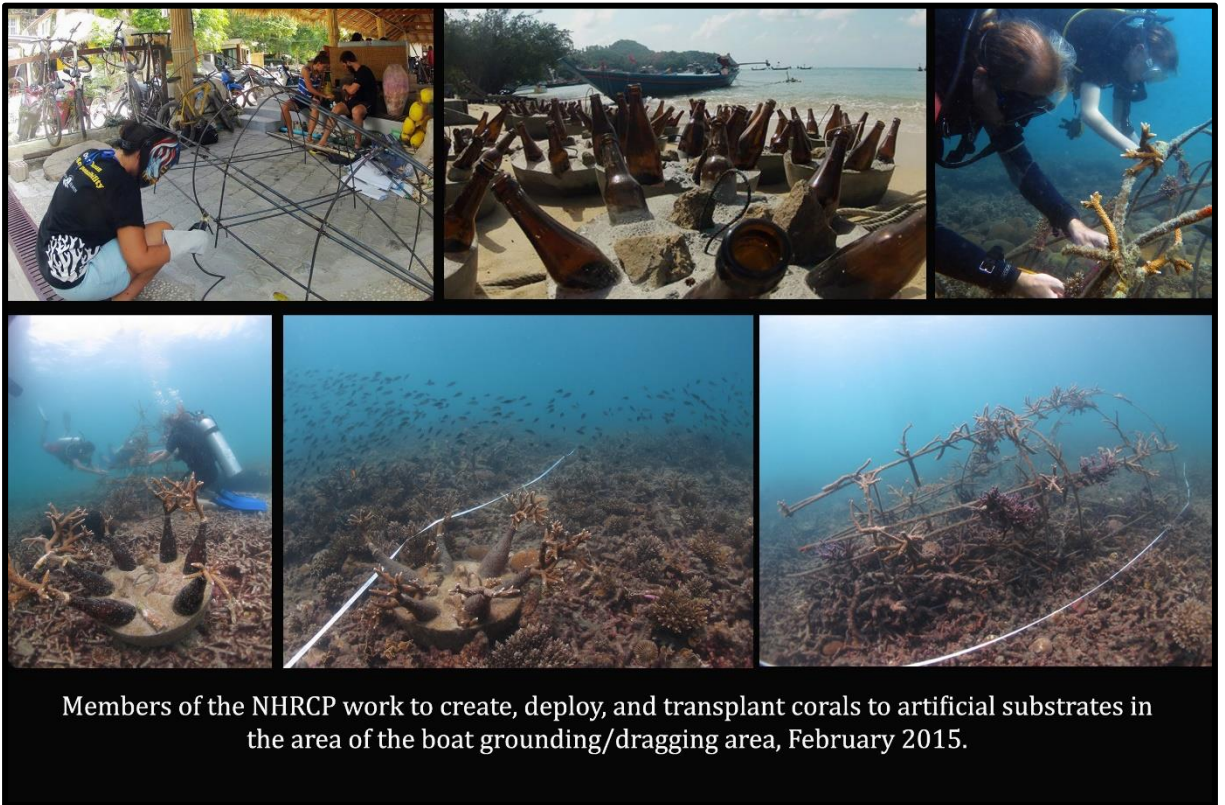
Members of the NHRCP work to create, deploy, and transplant corals to artificial substrates in the area of the boat grounding/dragging area, February 2015.

second, was welded steel rebar structures which were designed to fit into the drag mark and upon which the broken coral fragments were attached using small nylon rope and a hitching technique. The nylon line is either grown over by coral tissue and integrated into the skeleton, or removed later on. The structures were made in the shape of tunnels to increase the 3-dimensional complexity of the reef and provide habitat for a variety of reef fishes. Both substrates were used to attach and secure only larger (>15 cm), visually healthy fragments of coral. All coral growth forms/genera present were utilized in order to preserve reef diversity on a genetic and species level.

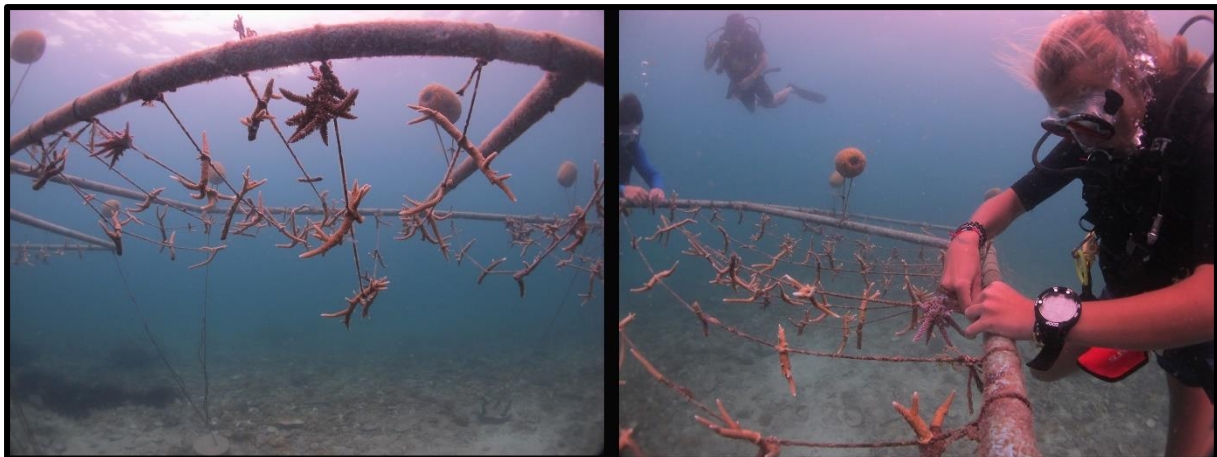
Divers install a mid-water 'rope' nursery to rehabilitate the fragments created by the boat grounding

A floating mid-water nursery was installed on the adjacent reef slope, and set to the same depth as the boat drag mark. Here, smaller (<15 cm) or visually unhealthy corals were secured using the rope nursery method in order to allow for their rehabilitation and growth before later transplantation back to the reef and artificial substrates. The nursery was filled with the fragments of corals found broken within the drag mark, regardless of species or growth form. Care was taken to preserve genetic and species diversity by collecting a broad range of fragments from across the entire span of the boat drag mark area.

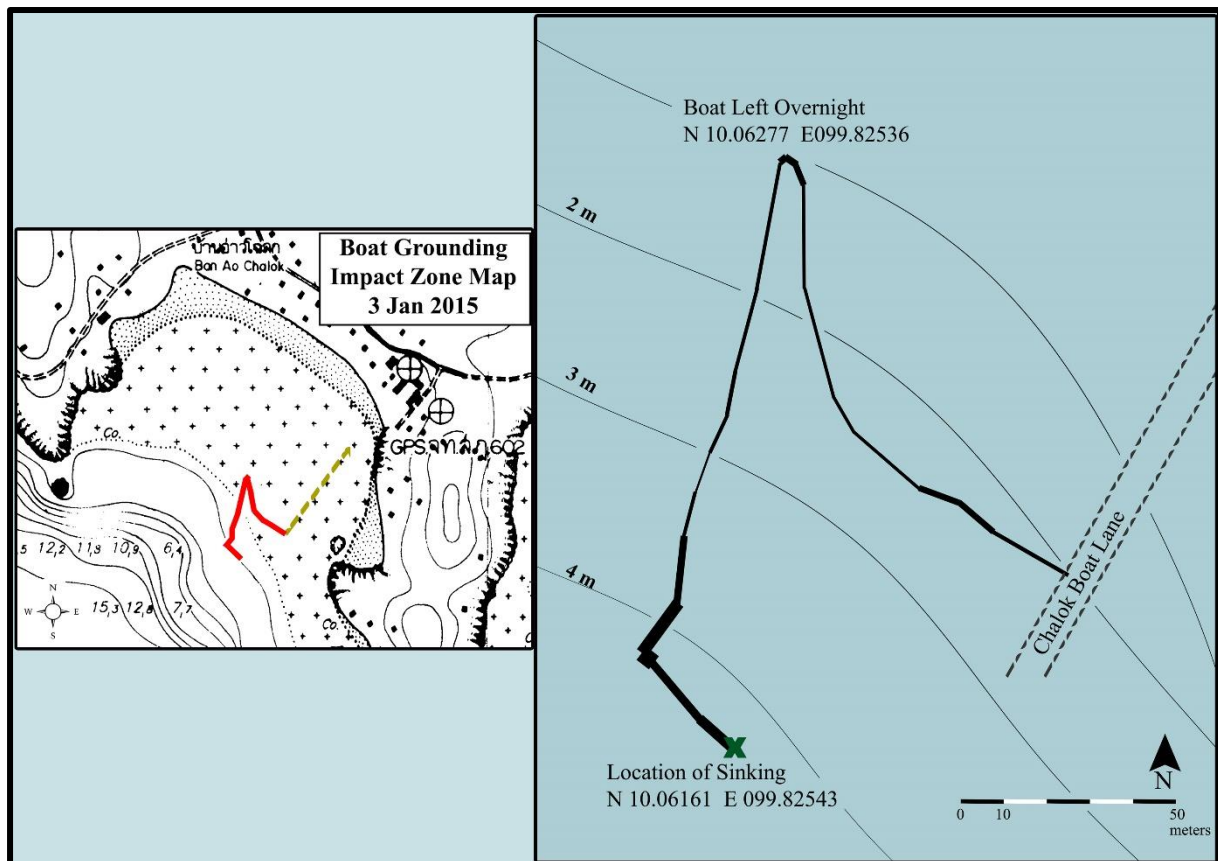
The boat drag mark was found to have a length of 270 meters from the point of grounding to the intersection with the already established boat lane. The drag mark varied in width from 0.5 m to 7 meters, with a mean width of 2.19 m (SE  $\pm$  0.2m). The total calculated area of reef disturbed by the dragging of the boat was approximately 591.5 m<sup>2</sup>. The route taken to drag the boat from the grounding location to the boat lane is shown in the figure below.

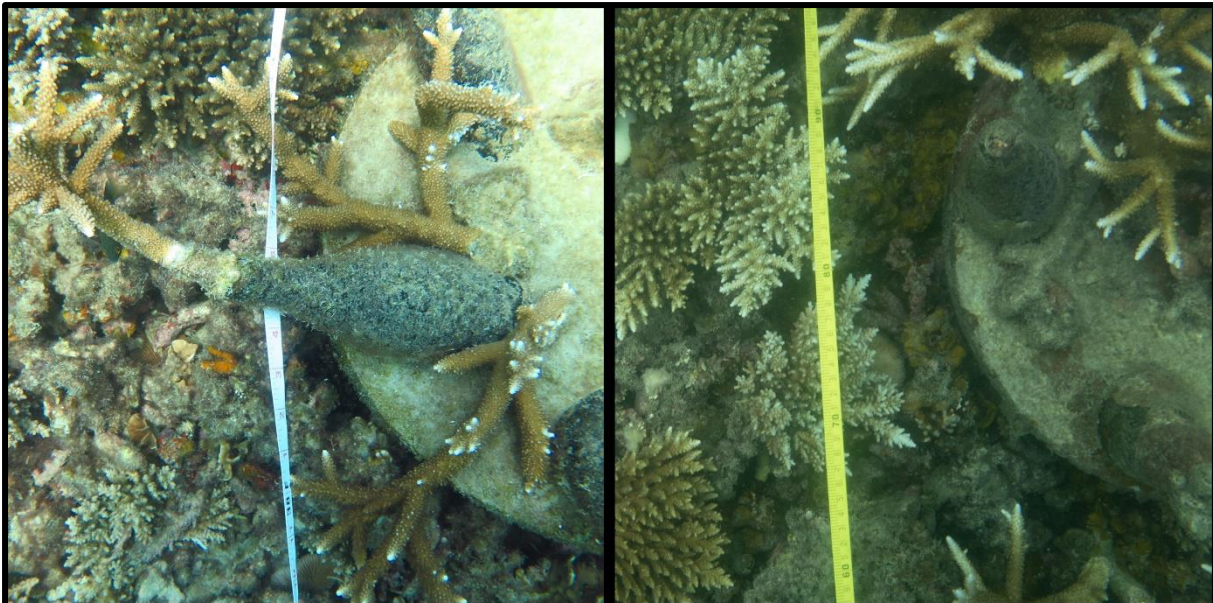
The results of the restoration efforts become more apparent in the data collected over 4 years later, in June of 2019. As shown in the table above, coral coverage on the reef as a whole increased greatly, with the control reef increasing in coral coverage from 18.6% to 46%, greater than a 2-fold increase. Coral coverage increased even more dramatically in the restored boat drag mark, reaching 55.2% coral. This is most likely due to the effects of adding artificial substrate which provides more effective securement of coral fragments and natural recruits as opposed the coral rubble which was previously the most prevalent substrate type.

**March 2015**

**June 2019**

**Two samples from the phototranssect survey, showing the change in coral abundance between the two years**
