# Incident Report and Restoration Overview: Boat Grounding, Chalok Ban Kao Reef January 27th, 2015

## Incident Report and Restoration Overview Boat Grounding: Chalok Ban Kao Reef January 27<sup>th</sup>, 2015

Written by Chad Scott

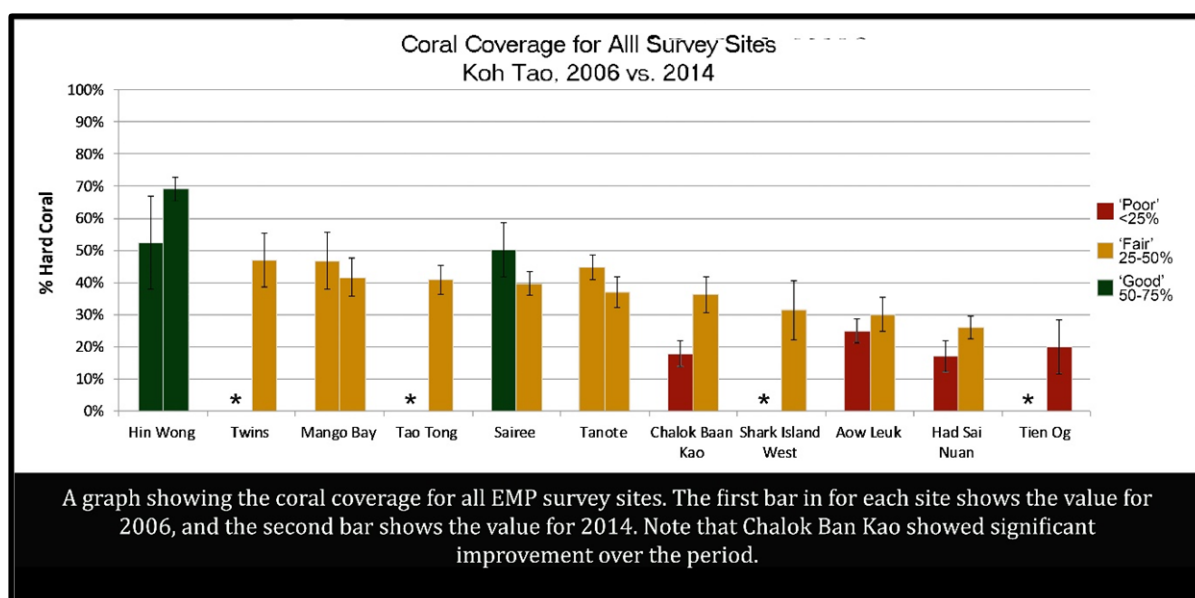
Chalok Ban Kao is a reef located in a secluded bay on the Southern end of the island of Koh Tao, Thailand. The bay consists of a shallow reef (1-5 m) which is primarily dominated by branching *Acropora* corals. The reef crest and slope (5.1-8 meters) is primarily dominated by mushroom corals, followed by the deeper reef which is primarily sand with scattered massive *Diploastrea* corals. The Bay is an important economic site for tourism activities, including snorkeling and diving, as well as the most ecologically rich bay on the southern end of the island. Chalok Baan Kao has been affected by several mass disturbance events and chronic stressors over the last 3 decades, beginning with typhoon Gay in 1989, which caused a large amount of structural damage to the area (Vongvisessomja 2009). The coral structure of the bay was further impacted by Typhoon Linda in 1997 (Vongvisessomja 2009, Phongsuwan et al. 2013). The following year, the bay was hard hit by the bleaching event of 1998, greatly reducing coral cover, especially for more vulnerable Acroporid and Pocilloporid species (Yeemin 2006, Phongsuwan et al. 2013). The reefs were left little time to recover, as mass bleaching occurred again in 2010 (Phongsuwan et al. 2013) causing around 60% mortality in the shallow reef (<6m depth) of the bay (Scott et al. 2017). However, our data shows that overall, the amount of coral in the bay increased between the years of 2006 and 2014, as the reefs recovered from Typhoon Gay and the 1998 bleaching event, as shown below.

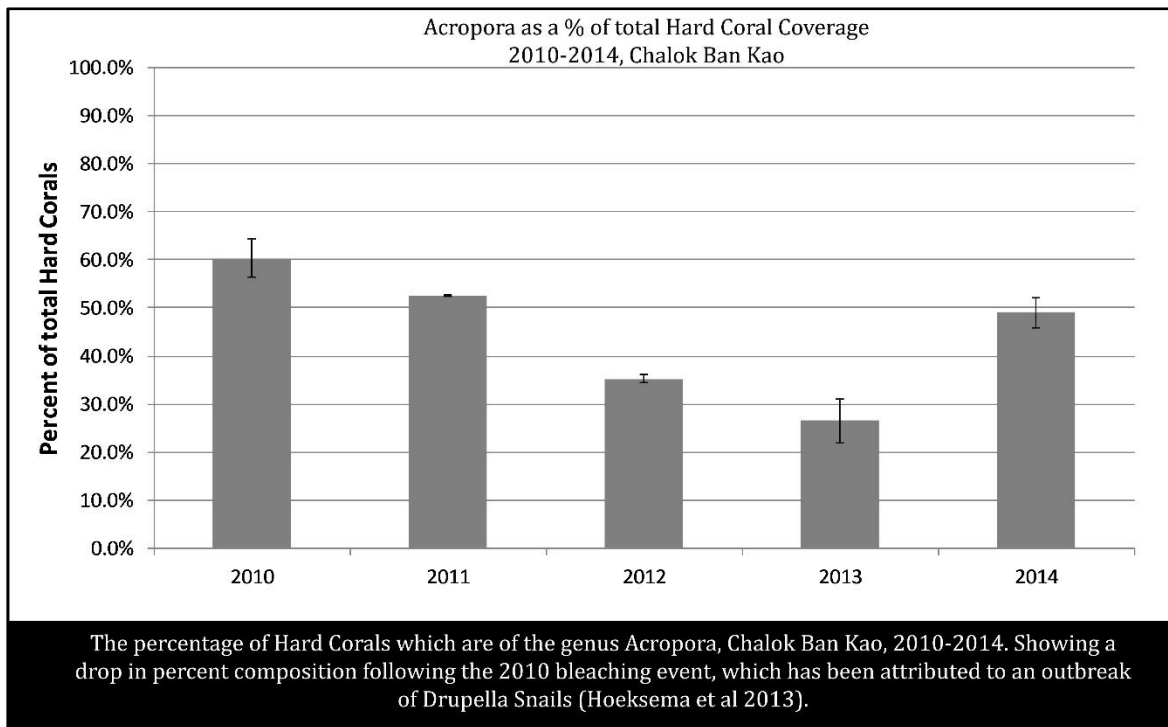
chronic predation by *Drupella* snails. However, data indicates that predation rates were highest following the 2010 bleaching (Hoeksema et al 2013) but has since been reduced following the collection of more than 51,000 *Drupella* snails by the New Heaven Reef Conservation Program.

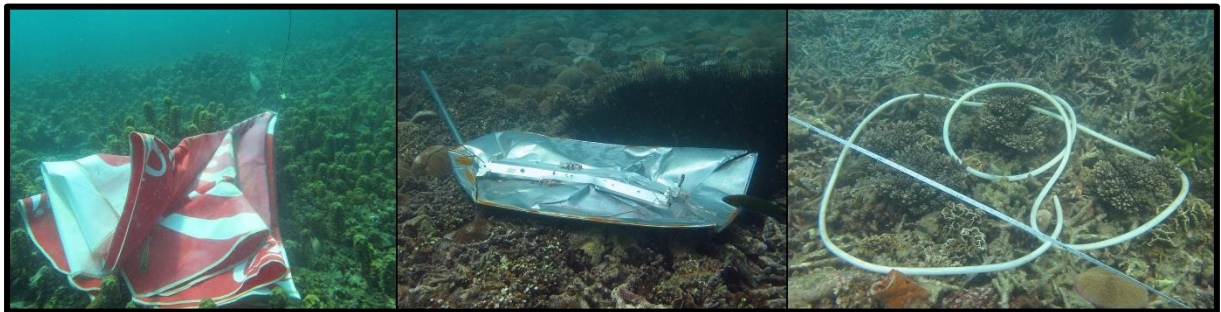
An initial roving diver survey was completed on the morning February 2<sup>nd</sup>, 2019 to assess the damaged areas and create a plan. As there was a high amount of debris in the area that had come from the boat, one team was left in the water to perform a clean-up to prevent the debris from causing further damage to the reef through wave action.
